GLENWOOD LAKE DAM

NDI ID NO. PA-00327

PHASE I INSPECTION REPORT
NATIONAL DAM INSPECTION PROGRAM

JULY 1981

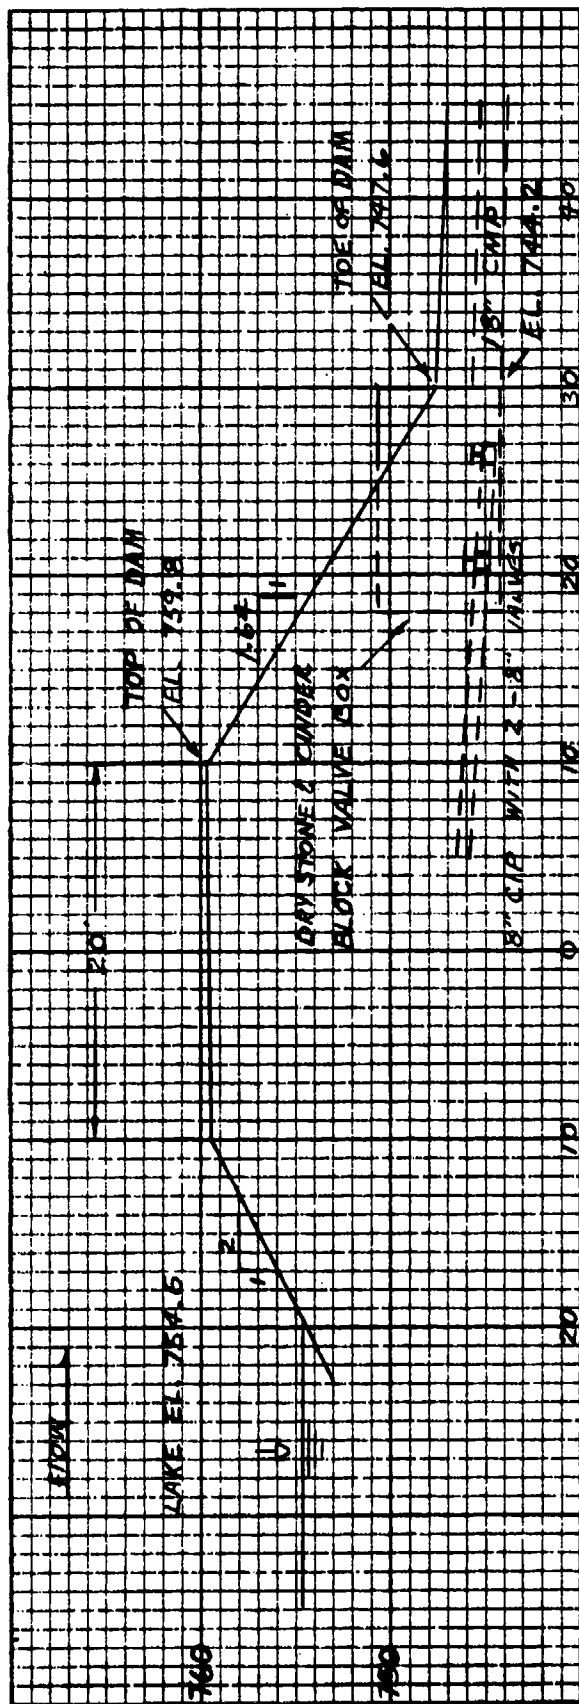
OUTLET WORKS

(2) Outlet Works: The intake facilities of the outlet works are under water and their construction or condition could not be verified. The outlet conduit is an 8-inch diameter cast iron pipe (CIP) with two 8-inch diameter gate valves. The upstream valve was open and its operating wheel was missing. The downstream valve turned easily to control discharge. Both valves near the downstream toe of the embankment are enclosed in a dry stone masonry structure. The structure is 3.8' wide by 10.2' long by 5.5' high, with a concrete top slab (8" thick) in fair condition. The downstream endwall at the structure is constructed with loose cinder blocks and the entrance cover plate is missing. The poor condition of this end of the outlet structure is shown in photographs 6 and 8, Appendix C. The valve pit structure is drained by an 18-inch corrugated metal pipe (CMP) that extends underground a distance of about 90 feet to the stream channel downstream of the spillway (see Exhibit A-1 and Photograph 7). About 1/4 GPM was leaking from the outlet structure side walls and floor.

The maintenance of the dam is inadequate. The trees and brush should be removed from the dam proper. The trash inside the ice house foundation walls should be removed to avoid attracting rodents. The downstream wall of the outlet structure should be repaired and the missing entrance cover plate should be replaced. The upstream slope of the dam should be protected with suitable riprap along the entire length of the dam. The owner should institute regularly scheduled maintenance inspections. Findings and subsequent maintenance and repair work should be documented. An emergency warning system is necessary to detect adverse conditions at the dam and to prevent loss of life should the dam fail.

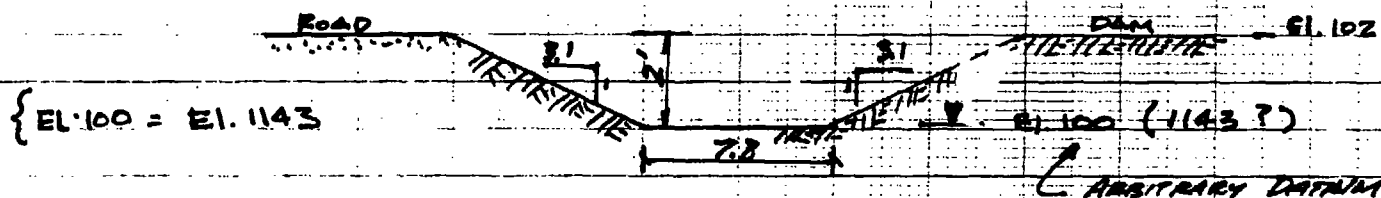
DAM SECTION

DAM HAS LOW SPOT ON RT. ABUT.

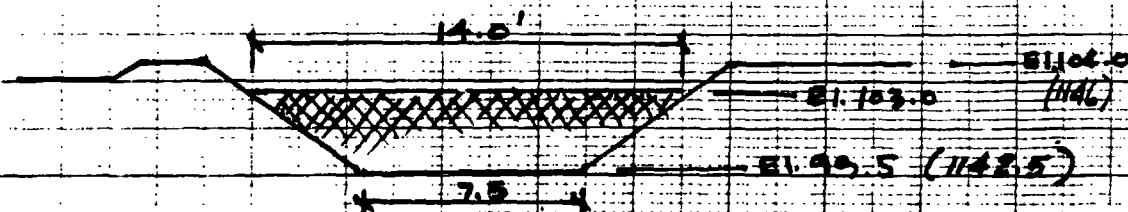
PREVIOUS BREACH

THE POND HAS BEEN PREVIOUSLY BREACHED BY A CHANNEL
IN THE TOPOGRAPHIC SADDLE TO THE NORTHWEST. THIS
CHANNEL IS PRESENTLY BLOCKED BY A BEAVER DAM
WHICH HAS A SMALL AMOUNT OF SEEPAGE THRU IT

THE BEAVER DAM IS 1.0 ABOVE THE EARTH DAM - UNLESS
STAGES REACH 104! IT WILL BE ASSUMED THAT ALL FLOW DISCHARGES
IN THE DIRECTION OF CONVEY SLUMP

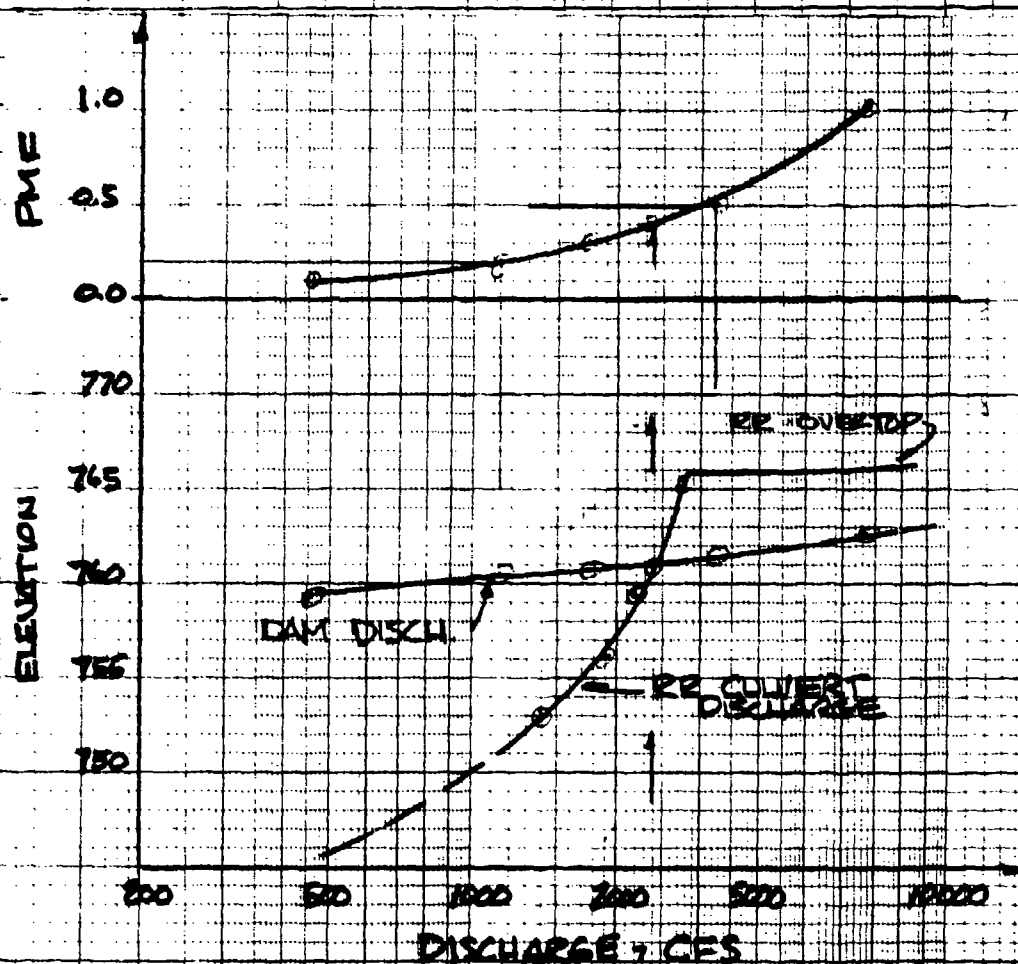
1. FLOOD FLOWS GREATER THAN 20.4 PMF WILL CAUSE SUBMERGENCE OF THE DAM BY BACKWATER FROM THE R.R. EMBANKMENT

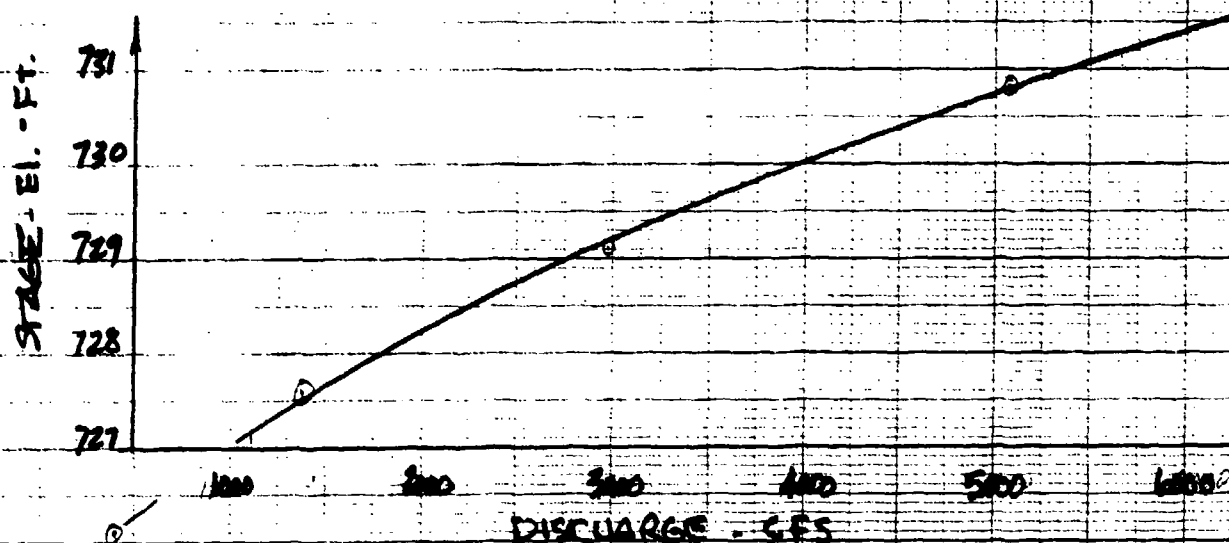
OVERTOPPING FAILURE BEGINS AT RESV. ELEVATIONS
OF APPROX. 760.3

DISCHARGE AT THIS ELEV. IS 1135 cfs
ASSUMING INSIGNIFICANT ROUTING EFFECTS DOWNSTREAM
THE CULVERT HEADWATER ELEVATION WOULD BE 751±
STAGE AT THE DAMAGE CENTER WOULD BE 727.2

PEAK DISCHARGE FROM DAM BREACH = 4148 cfs (0.2 PMF)
= 4391 cfs (0.5 PMF)

ANEL. OF 766± IS REQUIRED TO PASS THE PEAK BREACH FLOWS AT THE RR.
CULVERT WHICH IS WELL ABOVE THE PEAK RESV. STAGE OF 760.3. THEREFOR
HYDRAULIC CONTROL SHIFTS FROM THE DAM TO THE RR ENB. CAUSING
BACKWATER FROM THE ENB. TO SUBMERGE THE BREACH. FOR AN
ESTIMATE OF DAMAGE DOWNSTREAM ASSUME THE FLOW VOLUME FROM
THE BREAK IS SUFFICIENT TO CAUSE THE BACKWATER PEAK TO BE
NEAR THE PEAK RESERVOIR STAGE LI EL. 760±
AT EL. 760 THE CULVERT DISCHARGE IS 2330± cfs
A DISCHARGE OF 2330 cfs CAUSES A STAGE OF EL. 728.6
AT THE DAMAGE CENTER OR A RISE IN WATERSURFACE OF
+1.6 FEET
